New Zealand Helicopter Association Safety Bulletin

History of helicopter safety in New Zealand

SB 2

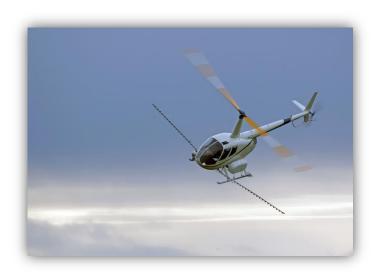
Accidents of this type predominantly affect light utility models:

Model	Total accidents
R22	29
Hughes 300	10
R44	6
Hughes 500	2
Other	2
